EG4010

**FATIGUE DAMAGE TO METAL BATTENS
SUBJECTED TO SIMULATED WIND LOADS**

Rebecca Fowler

Bachelor of Civil Engineering with Honours

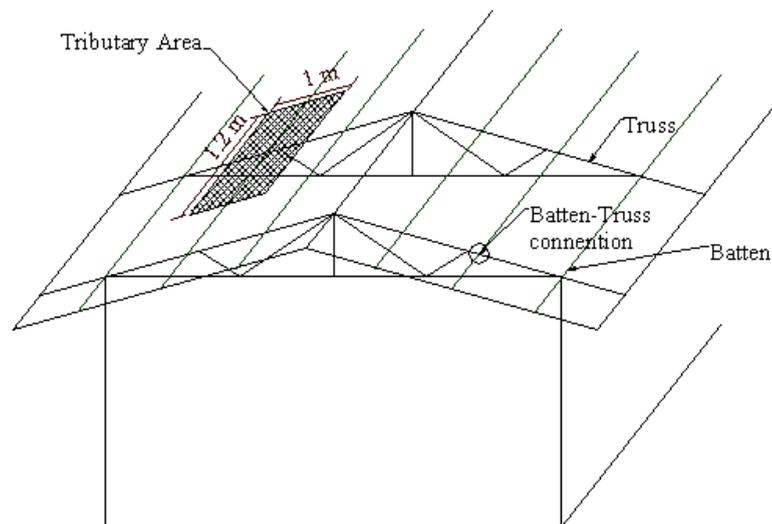
The traditional 40mm deep timber battens are being increasingly replaced by thin-gauge steel “top-hat” battens. The typical low-rise domestic house roof systems in Australia consist of battens placed at about 1.0m intervals and attached to roof trusses installed up to 1.2m apart. However, the batten and truss spacing vary depending on the batten type, manufacture’s specifications and the wind classification. In these systems, the batten-truss connection has to resist wind loads acting on a tributary area of up to 1.2m^2 as shown in Figure 1.1.

Figure 1.1 Typical domestic house roof system

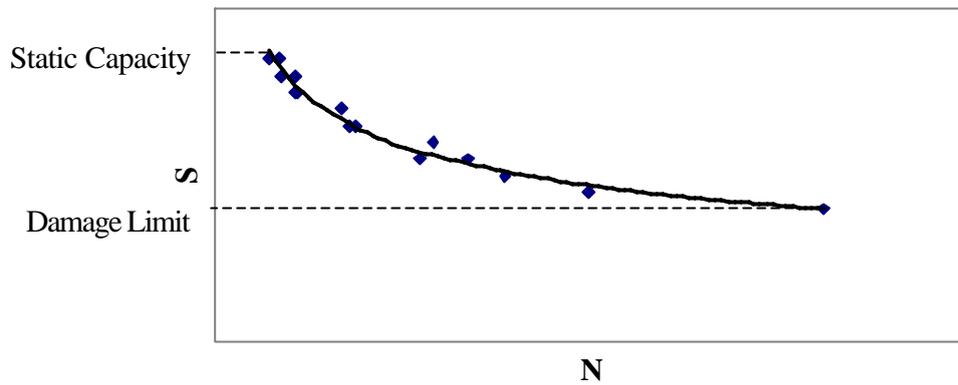
Figure 2.1 Form of typical S-N curve

The number of cycles to failure changes with stress level and may range over several orders of magnitude. For this reason, the cycle numbers are usually plotted on a logarithmic scale [8]. Another characteristics of the S-N curve is that there are typically threshold bounds, this is where failure occurs at only one cycle at a load greater than or equal to the static capacity. Furthermore, once the stress cycle is below a certain load limit the number of cycles will not have a significant damage effect on the component as shown in Figure 2.1.

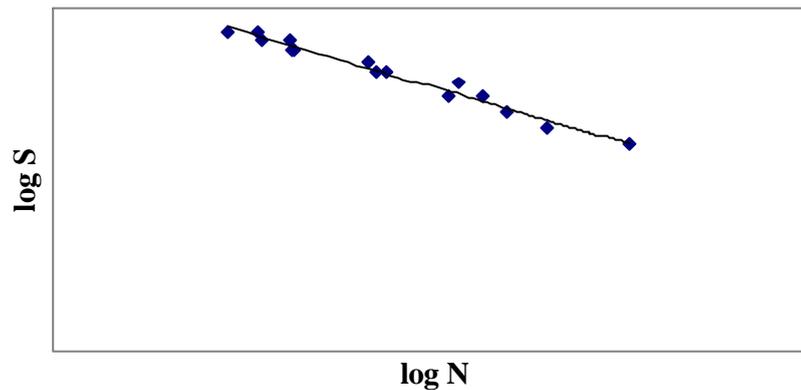
In the usual failure model for the fatigue of metals it is assumed that each cycle of a sinusoidal stress response inflicts an increment of damage, which depends on the amplitude of the stress. Each successive cycle then generates additional damage which accumulates in proportion to the number of cycles until failure occurs. The results of constant amplitude fatigue tests are usually expressed in the form of an S-N curve, where S is the stress amplitude, and N is the number of cycles until failure. For many materials, the S-N curve is of the form shown in Figure 2.1. This is represented by a straight line when $\log S$ is plotted against $\log N$ as shown in Figure 2.2. This implies an equation of the form

Figure 2.2 Form of a typical S-N curve when log S is plotted against log N

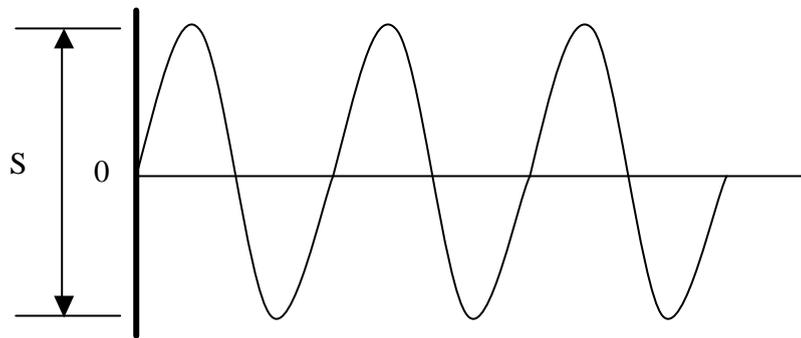
Figure 2.3 Cycling about zero mean

- Cycling amplitude S , with mean of zero as shown in Figure 2.3.
- Cycling amplitude S , with a specified nonzero mean as shown in Figure 2.4
- Cycling amplitude S , with a constant stress ratio, R as shown in Figure 2.5, with $S_{\min} = 0$ and the stress ratio is

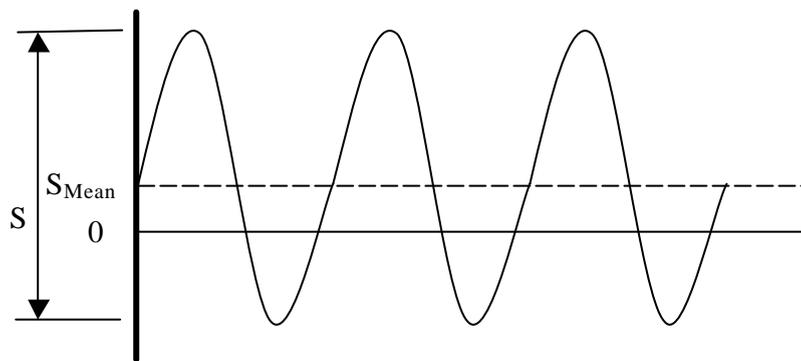
Figure 2.4 Cycling about a specified nonzero mean

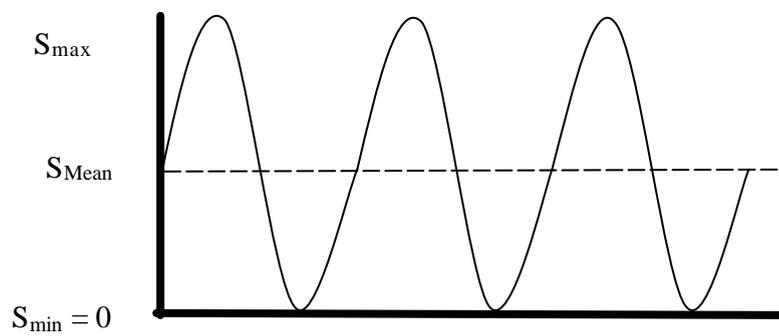
Figure 2.5 Cycling between zero and S_{\max}

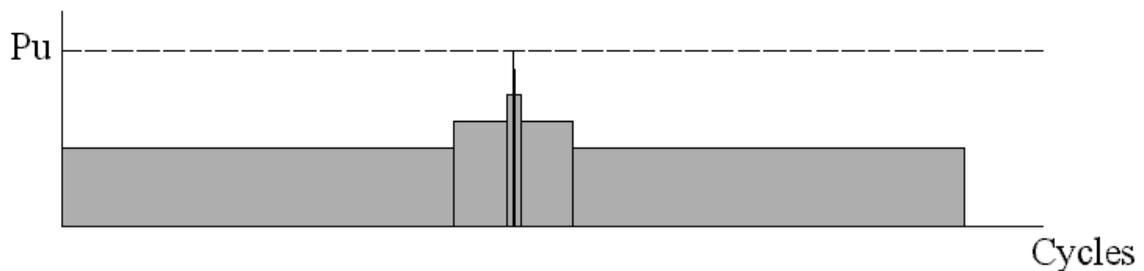
repeatable product evaluation. This four level, low-high-low regime, represents the loading by the passage of a cyclone, representing the wind speed increasing as the eye approaches and then decreasing as the cyclone moves way. Miner's rule was used to simplify the RBL matrix of load cycles, by comparing fatigue damage of loading blocks of similar load levels from the RBL matrix, and finding an equivalent number of cycles in the loading block of the LHL. Figure 2.6 shows the loading sequence of the LHL method where P_u is the ultimate design load [11], [14].

Figure 2.6 Low-High-Low loading regime

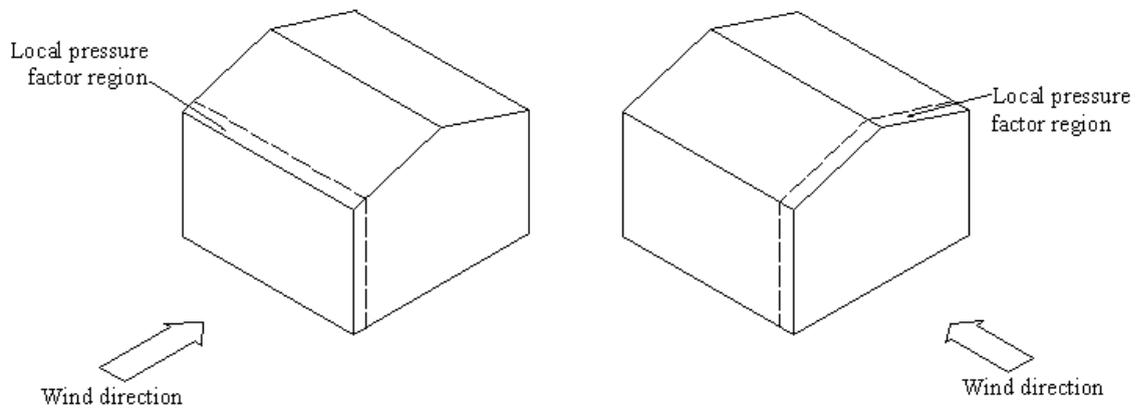
Figure 2.7 Areas on the roof and wall subjected to high pressures with a local pressure factor of $k_1 = 2$

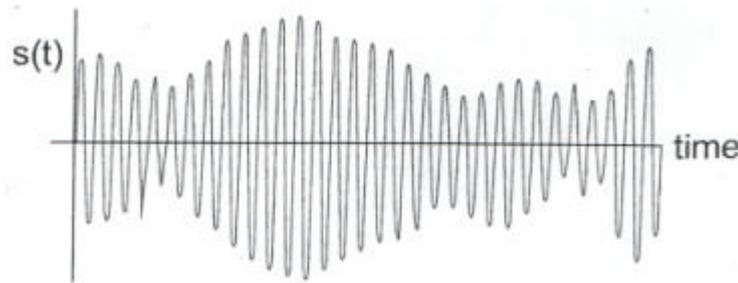
Figure 2.8 Narrow band random vibrations [13]

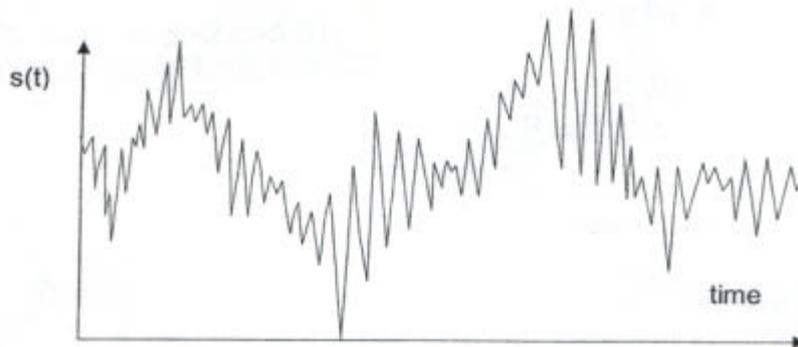
The variable nature of wind loading produces fluctuating stresses in structures with contributions from resonant and background (sub-resonant) components. For most structures wide band background contribution is usually the dominant source of fatigue damage. Some wind loading situations produce resonant narrow-band vibrations as shown in Figure 2.8. Wide band random vibrations consists of contributions over a broad range of frequencies, with large background response peaks, this type of response is typical for wind loading, as shown in Figure 2.9.

Figure 2.9 Wide band random vibrations [13]

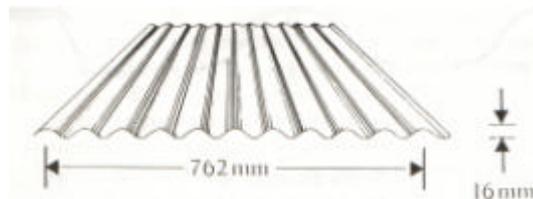
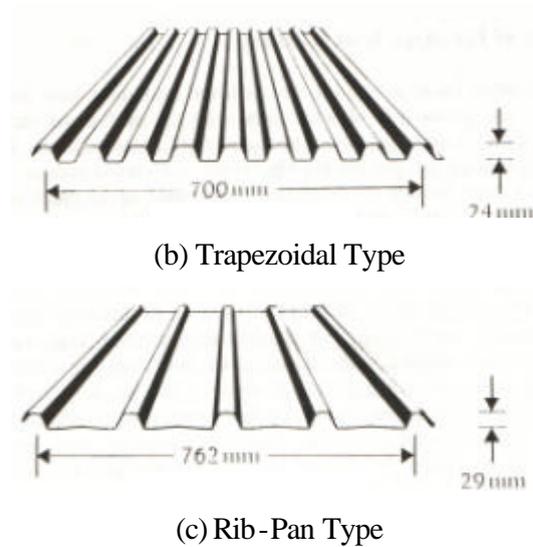
The most common light gauge metal cladding used in domestic roofing is of the corrugated or rib/pan profiles, and is rolled from 0.42mm bmt G550 coil. The measured mean yield stress typically exceeds 700MPa, satisfying the minimum yield stress for G550 of 550MPa. The mechanical properties vary in the longitudinal and transverse directions of the coil. Three common pierce fixed profiles are shown in Figure 2.10.

(a) Corrugated Type

Figure 2.10 Common cladding profiles [24]

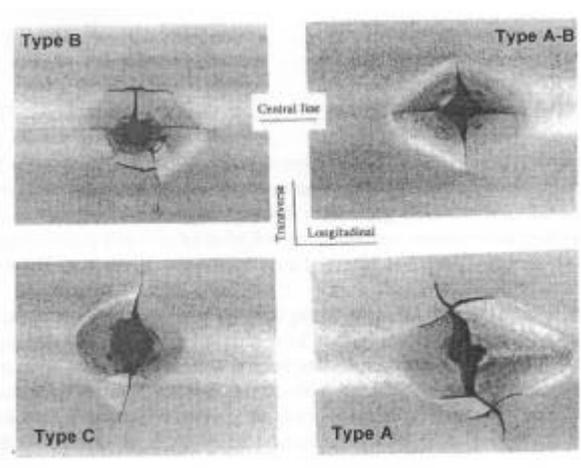
From extensive constant amplitude cyclic load tests for the corrugated profile, different crack propagation modes were observed for cycling at different load levels. Sample data collected in laboratory experiments showed the variable nature of fatigue of claddings, which is not just limited to the variation in material properties across the coil, but also includes tightness, alignment and position of the screw on the crest or rib. Figure 2.11 shows the different modes of crack initiation and propagation indicative of different fatigue responses depending on the load levels. Figure 2.12 shows the S-N curve for corrugated cladding fastened without cyclone washers. For the constant amplitude load tests, when the load per cycle is well below the LPD load of 600N, cracks propagated from the screw hole along the crest (Type B in Figure 2.11 and Segment 1 in Figure 2.12). When the load per cycle is around 500N per fastener (approaching LPD) cracks propagate in both longitudinal and transverse directions (Type A-B in Figure 2.11 and approaching Segment 2 from Segment 1 in Figure 2.12). For loads cycling through the LPD cracks initiated at the edges of the flattened crests where the cladding creases, with the cracks then progressing towards the screw hole and failure within 1000 cycles (Type A in Figure 2.11 and Segment 2 in Figure 2.12). The Type C failure is from a few cycles at high loads, not unlike a straight static pull through failure [11], [15], [23] and [24].

Figure 2.11 Crack patterns from constant amplitude cyclic loading [11]

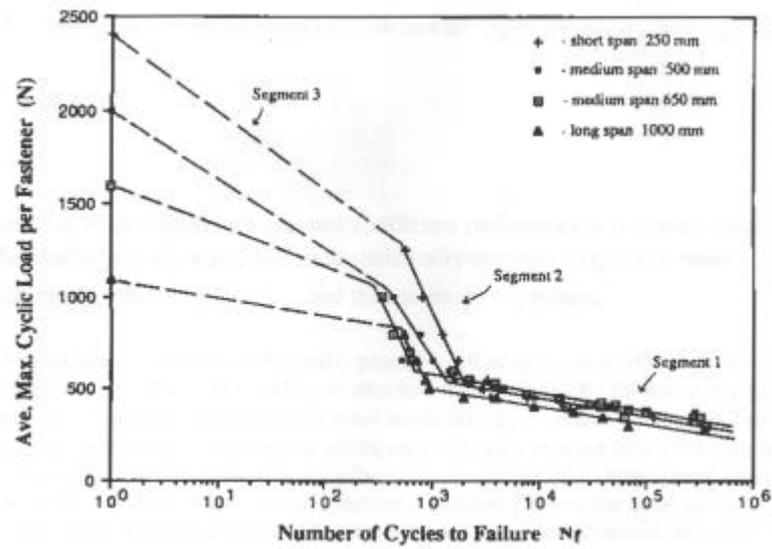
Figure 2.12 S-N curve for corrugated cladding fastened without cyclone washers [15]

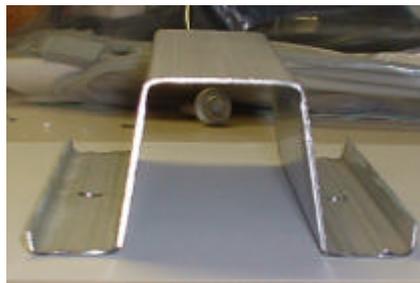
Figure 3.1 Cross-section of Stramit Cyclonic Roof batten

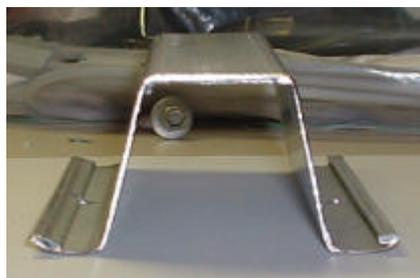
Figure 3.2 Cross-section of BHP Topspan 40 batten

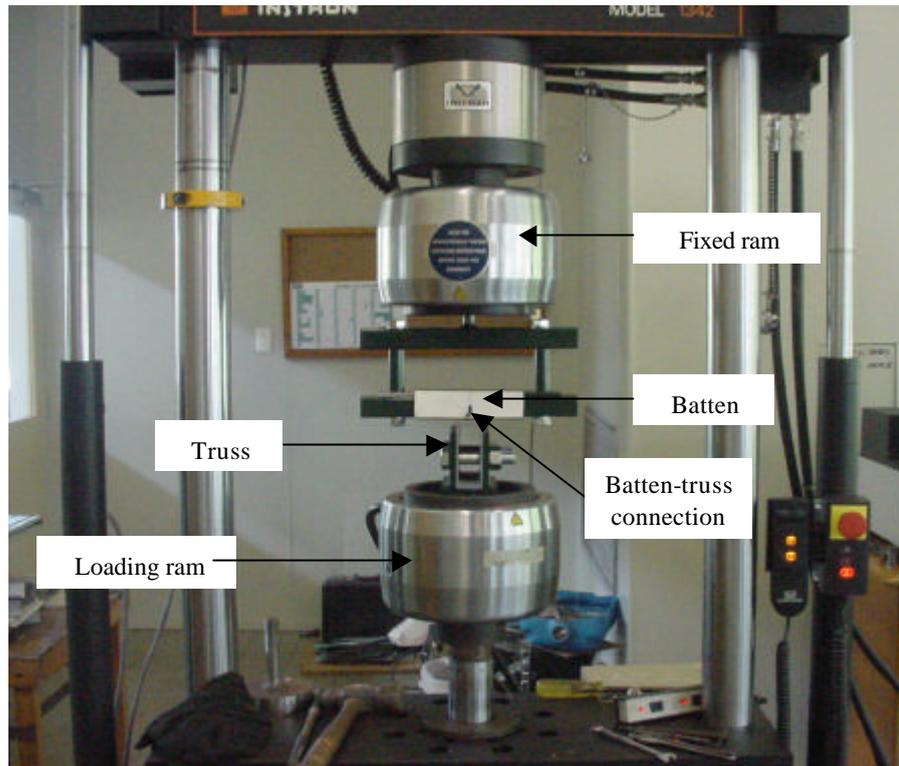
Tests were conducted on the INSTRON (model 1342) universal testing machine with a capacity of 100kN, in the structures lab at the School of Engineering, James Cook University. The INSTRON was calibrated using a proving ring before testing was undertaken. The calibration results are shown in Appendix B. A testing apparatus which simulated the batten-truss connection had to be designed in order to carry out the tests. The lengths of the test specimens were specified as 150 mm, allowing the testing apparatus to be designed to easily fit into the INSTRON. The apparatus was designed to allow the batten to be subjected to static and cyclic loads. This was done by ensuring the apparatus could apply a constant loading rate as well as a sinusoidal load to the batten. Figure 3.3 shows the batten-truss connection apparatus attached to the INSTRON and Figure 3.4 shows a schematic diagram of the testing apparatus. A SHS bar supports the top of the batten and is attached to the fixed ram on the INSTRON. The batten was bolted to the truss which was connected to the loading ram. Loads were applied by displacing the loading ram downwards at a constant rate for the static tests and by applying sinusoidal loading wave for the cyclic tests. However, the apparatus design was limited to bounds cycling from zero or greater to a nominated upper bound, simulating a suction loading.

Figure 3.3 Test Setup

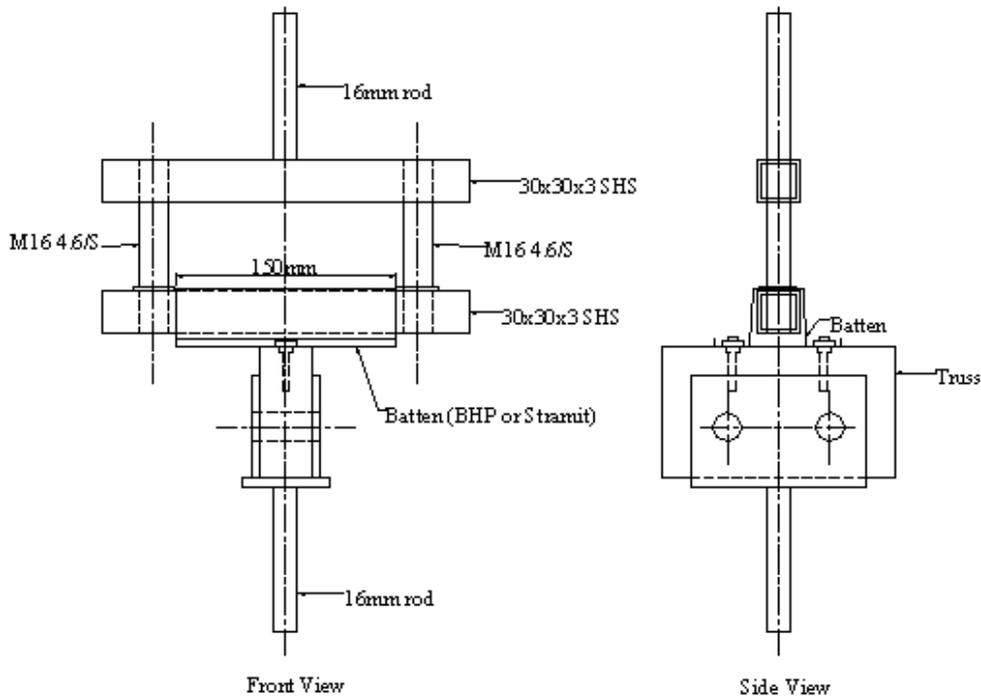
Figure 3.4 Schematic of testing apparatus (not to scale)

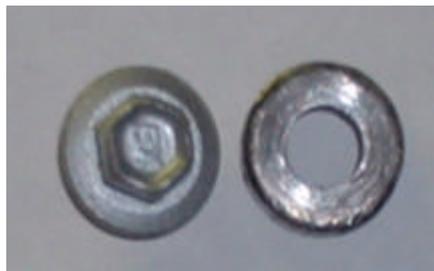
A number of trials were conducted to devise a satisfactory test setup. Initially the batten was attached to a timber truss however, the timber trusses encountered problems with splitting or screw failure. To overcome this problem a metal block was constructed from 6mm plate; two holes were predrilled in the top of the block so that the batten could be bolted to the truss. Washers were made up to the dimensions of the 12 gauge screw washer. The thickness of the washers were altered after the first two static tests as the thin washer was buckling and not simulating the screw washer. It was determined that a thicker washer with rounded edges (as sharp edges acted as a cutting tool), simulated the screw washer as shown in Figure 3.5. Figure 3.5 shows the comparison of the screw head used to fasten the battens to the timber trusses and the washer used in the laboratory experiments.

Figure 3.5 Batten screw (12 gauge) and washer used in laboratory experiments

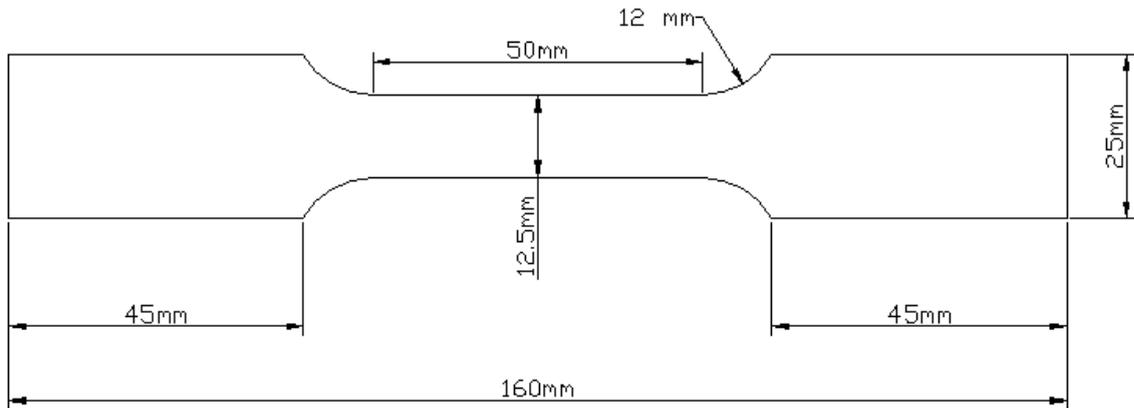
Figure 3.6 Tensile test dimensions (not to scale)

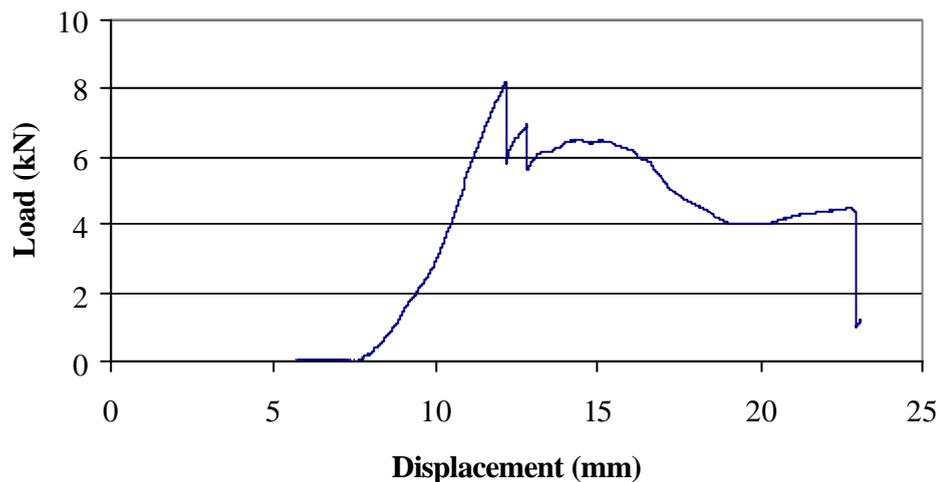
Static tests were performed on six BHP battens, with a number of static test trials conducted before the test setup was finalised. Detailed results for the trials and tests are given in Appendix D. A typical load vs. displacement curve from test results is shown in Figure 4.1. The load vs. displacement curve has two well defined peaks. An explanation for this is that both batten fasteners do not fail at the same time. The first peak is reached when the batten starts to fail on one side (crack initiation), and then the majority of the load is transferred to the other fastener until the batten tears around that fastener. Generally, the first peak load was higher; however for some tests the second peak was higher. In both cases the failure load was taken as the load at the first peak. Plots of load vs. displacement for the BHP battens are given in Appendix E. Summarised results for the six BHP static batten tests are shown in Table 4.2.

Figure 4.1 BHP Static Test load vs. displacement curve

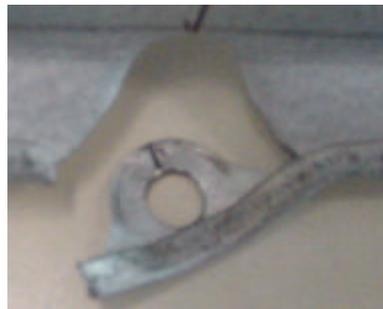
A typical static failure mode for the BHP batten consists of the crack pattern cutting out a semi-circular shape around the washer and angling out towards the edges of the batten, as seen in Figure 4.2. Another typical failure mode was the crack starting at the washer edge closest to the batten web and following along the web crease and then angling towards the edge, as seen in Figure 4.3. When comparing Figures 4.2 and 4.3 notice that the turned over edge in Figure 4.2 is narrower than the turned over edge in Figure 4.3. It was observed that disengagement of the batten from the connection occurred at this unsymmetric narrow turned over edge for all the BHP static load tests.

Figure 4.2 BHP batten static failure mode at narrow turned over edge

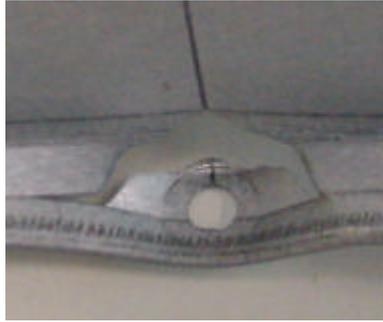
Figure 4.3 BHP batten static failure mode at the unsymmetric wider turned over edge

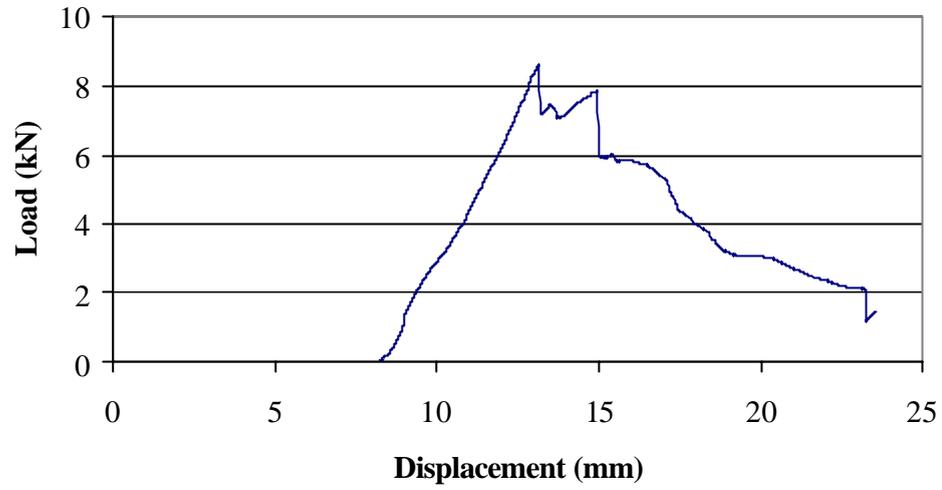
Static load tests were performed on five Stramit roof batten samples. The INSTRON recorded the load and displacement, and the plot of the load vs. displacement enabled the failure load to be determined. Stramit battens behaved differently to the BHP battens, and two types of load vs. displacement curves were observed as shown in Figures 4.4 and 4.5. Type 1 load vs. displacement curve, Figure 4.4 has the two well defined peaks similar to the BHP battens and the explanation for this is the same for the BHP batten. Type 2 load vs. displacement curve (Figure 4.5) has only one well defined peak. The postulation for the behaviour of this curve is that the cracking occurred simultaneously at both the batten-truss connections. Summarised results from the five Stramit static tests were recorded and are shown in Table 4.3.

Figure 4.4 Type 1 Stramit static test load vs. displacement curve

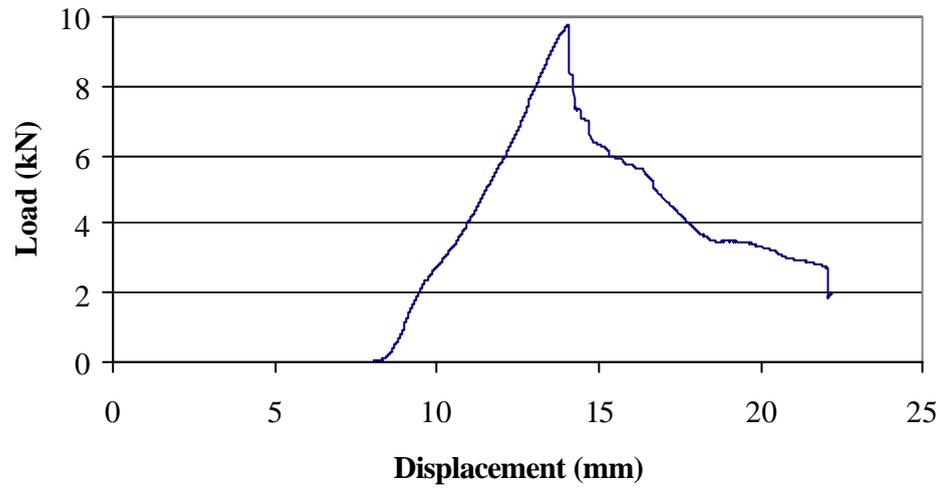
Figure 4.5 Type 2 Stramit static test load vs. displacement curve

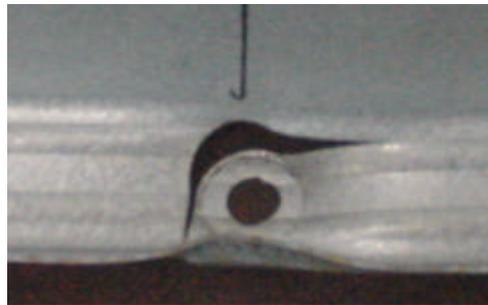
Typical observed failure modes for the Stramit batten are shown in Figures 4.6 and 4.7. Figure 4.6 shows the crack pattern following around the washer and moving longitudinally along the edge of the groove in the batten leg on one side and cracking to the edge on the other side. Figure 4.7 shows the batten cracking in a semi-circular pattern around the washer and then failing at the batten edge. Notice that the battens turned up edge is buckled next to the washer, where there are large stress concentrations.

Figure 4.6 Stramit Batten failure mode

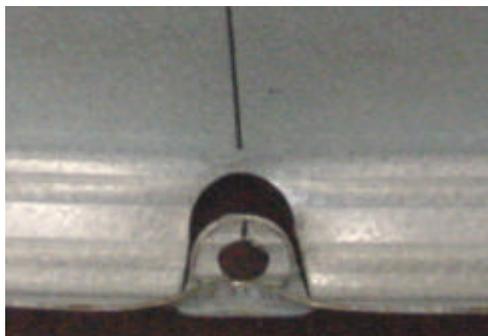
Figure 4.7 Stramit Batten failure mode

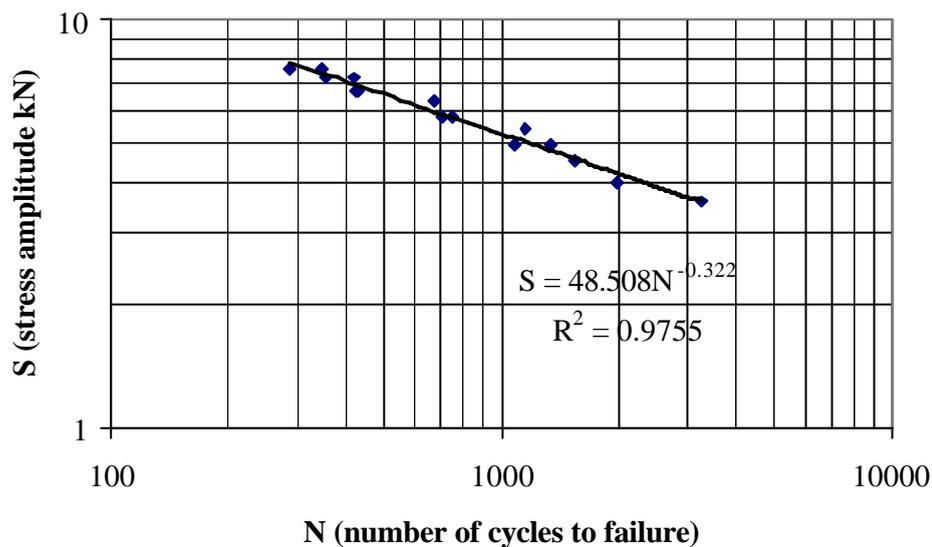
The results from the constant amplitude cyclic tests can be plotted to determine the S-N curve for the Stramit batten as described in Chapter 2. The load vs. number of cycles to failure (S-N curve) is well approximated by a straight line, shown in Figure 4.8. The equation for the line of best fit for the data points is found to be $S = 48.508N^{-3.22}$ where S is the stress amplitude in kN and N is the number of cycles to failure. The coefficient of determination (R^2) is 0.9755 giving a correlation coefficient $r = -\sqrt{0.9755}$. The negative

Figure 4.8 S-N curve for Stramit Cyclonic Roof batten

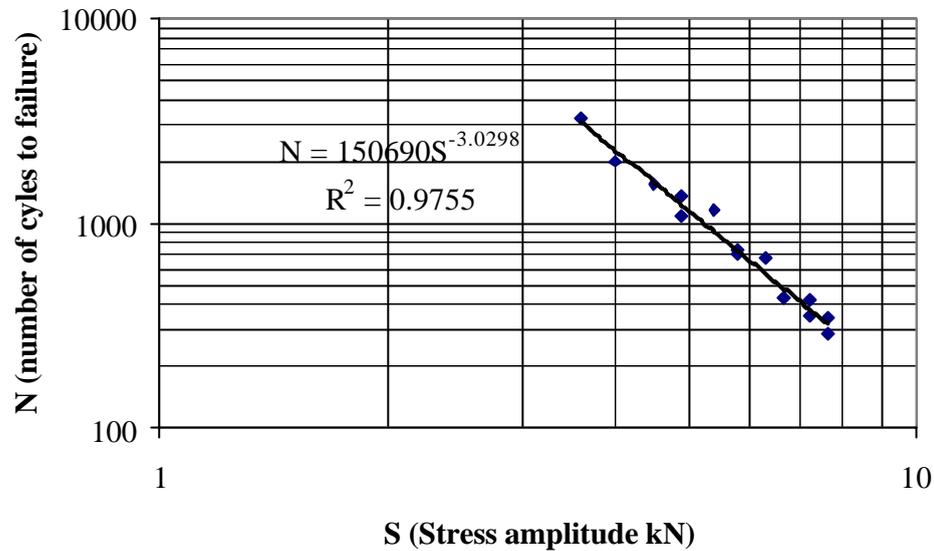
Figure 4.9 N-S curve for the Stramit batten

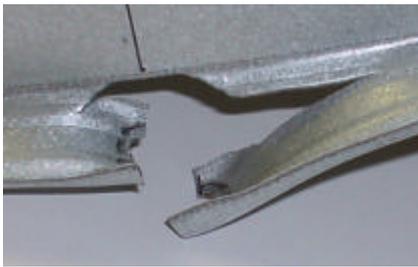
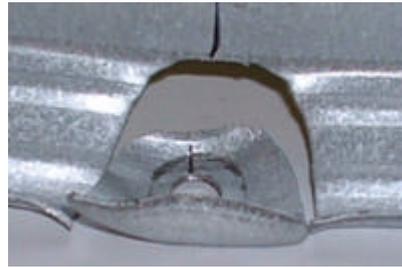
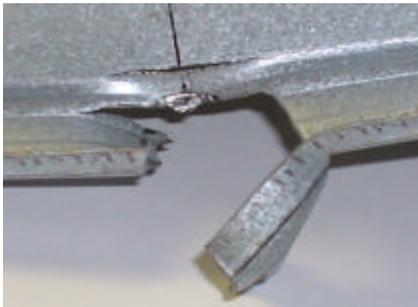
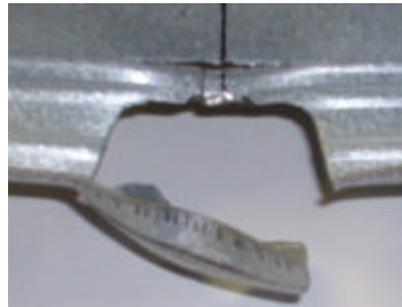
During the constant amplitude cyclic tests the batten's failure process was observed. The failure process consisted of the batten initially deforming plastically around the washer at the web crease and the turned up edge buckling in towards the washer where the stress concentrations were the highest. A 5 mm crack then formed on the underside of the batten, however at this stage it is not observed on the top side of the batten. The 5 mm crack then became visible on the top side of the batten and began to propagate longitudinally along the web crease. The crack progressed from a crack that opened and closed to a crack that stayed open due to the plastic deformation. Once the crack was open, disengagement of the batten from the truss connection was rapid, with the crack tearing out towards the edges in a failure mode shown in Figures 4.10, 4.11, 4.12, 4.13.

There are four noticeably different crack patterns for the constant amplitude cyclic tests as shown in Figures 4.10, 4.11, 4.12, and 4.13. Type A cracked longitudinally along the web crease and failed through the bolt hole, whereas Type B cracked longitudinally along the web crease and around the bolt hole, cutting a piece out. Type C and D cracked longitudinally along the web crease however, didn't fail along this crack instead failing at the bolt hole. Observations shown in Table 4.6 have found that crack Type A and B are

consistent with the higher loading greater than about 60% of the average static failure load, where as Type C and D crack pattern are associated with the load ranges lower than 60% of the average static failure load. Studies on cladding have found that this crack behaviour indicates a different fatigue response with the load levels giving a segmented S-N curve as shown in Figure 2.12. However, this does not look to be the case for the Stramit battens as the S-N curve can be well approximated by a straight line.

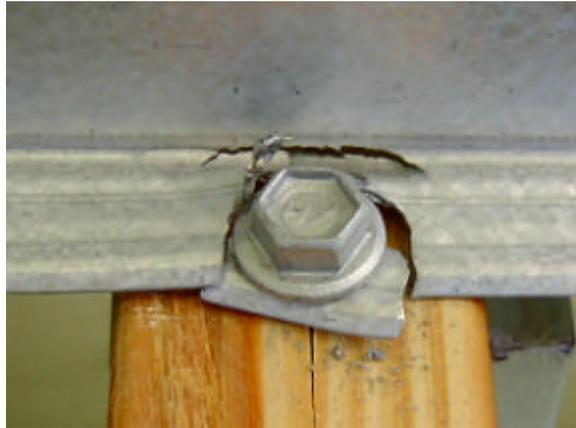
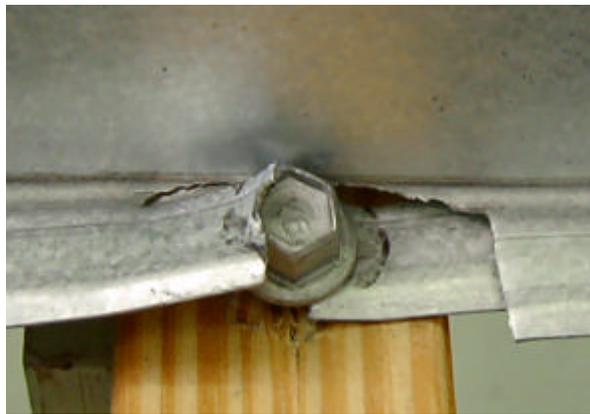
Full scale tests have been conducted on 0.75 bmt top hat roof battens for a building located in cyclonic area by the Cyclone Testing Station in the large pressure airbox at James Cook University [19]. Inspections of the crack patterns on the battens tested in the airbox have found that the crack behaviour closely resembled the crack patterns observed in these laboratory tests. Figures 4.14 and 4.15 show the typical crack patterns observed on the battens tested by the Cyclone Testing Station. Figure 4.14 shows a longitudinal crack along the web crease and the batten failing by tearing around the screw. This pattern is similar to the crack behaviour seen in Figure 4.13 (Type D). Figure 4.15 shows the crack forming longitudinally along the web crease and failing through the screw hole. This pattern is similar to the crack behaviour seen in Figures 4.10 (Type A). Figures 4.10 and 4.11 show that for loads greater than 60% of the average static failure load, failure occurs along the web crease. However, Figures 4.12 and 4.13 shows the cracks form along the web crease but fail at the bolt hole, which is characteristic of the lower loads.

Figure 4.14 Batten failure in Cyclone Testing Station air-box test

Figure 4.15 Batten failure in Cyclone Testing Station air-box test

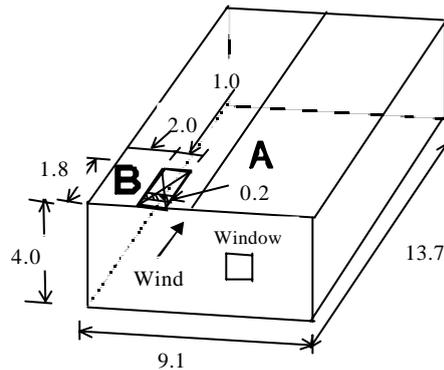
Figure 4.16 13.7 × 9.1 × 4.0 m full-scale Texas Tech building showing cladding-fastener tributary area A (1.0 × 0.2 m²) and batten-truss tributary area B (1.0 × 1.8 m²) [10]

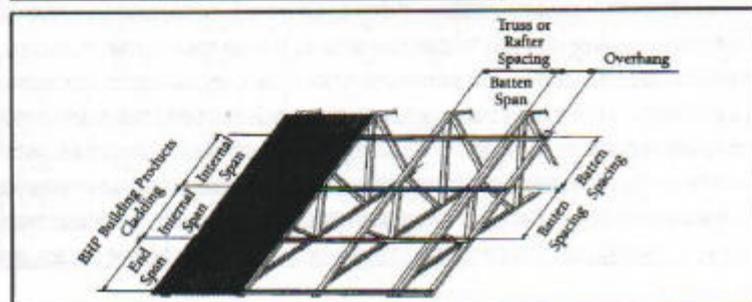
Allowable Batten Spacing In Non-Cyclonic Areas
