**Project Report
FCRC PR 00-02**

Fire Safety in Shopping Centres

Effect of Combustible Construction on Fire Safety in Shopping Centres.

FCRC Project 6 Supplement
Fire Safety in Shopping Centres

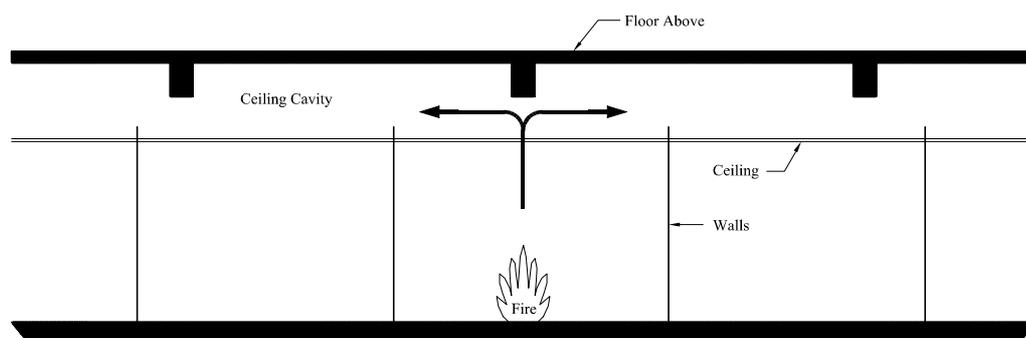
The review of the case studies indicated that non-compartmented ceiling spaces are a major cause of rapid smoke and fire spread. If the walls between the shops do not extend above the ceiling, providing a continuous ceiling cavity, then once the fire has broken through the ceiling, it can move horizontally within the ceiling space to adjacent stores. This method of fire spread is shown in Figure 1.

FIGURE 1: Fire spread through ceiling cavity

Fire spread to the adjacent stores, from the ceiling space, will occur by exposure of the combustibles to high levels of radiation when the ceiling has collapsed. If there is timber construction within the ceiling space, eg. the underside of the floor above is of timber, then the rate at which the fire will spread in this manner could increase. For fire spread through the ceiling space there are three combinations to be considered:

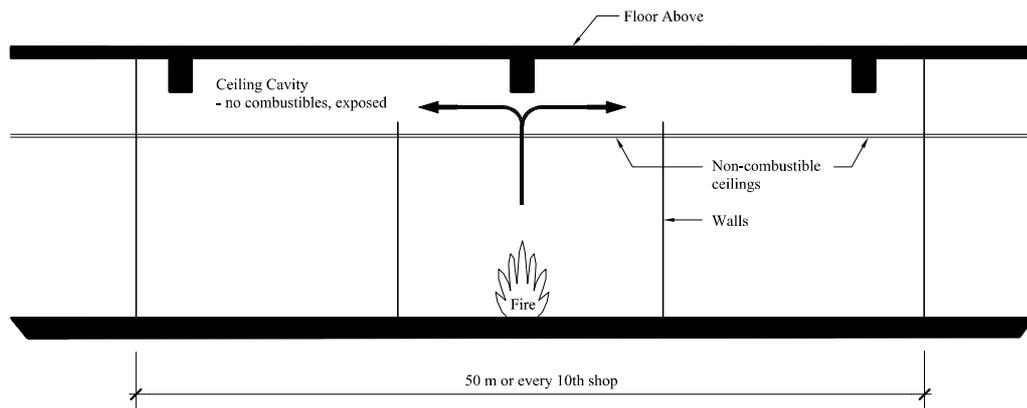
The presence of ceiling barriers at 50 m centres or every 10th specialty shop, whichever gives the closer spacing, as recommended by the Project 6 Report, would reduce the spread of the C3 fire and smoke. The ceiling barriers should be of protected lightweight construction, eg. plasterboard linings on steel or timber studs. There should be no gaps around the perimeter of non-combustible services penetrating the ceiling barriers. Any gaps around service penetrations through the ceiling barriers should be filled with a non-combustible material. This recommendation is more severe than the Project 6 Report which allowed a 50 mm gap around all penetrations. However, this recommendation is not requiring fire-rated construction, which would require additional expansive features such as fire dampers in ducts and intumescent collars around all plastic pipe penetrations. The ceiling barriers should be provided at the boundary between all shops (specialty shops and department stores) and the mall and between the specialty shops and the department stores. Figure 2 shows the ceiling barriers for this layout.

FIGURE 2: Ceiling barrier locations for no combustibles exposed in the ceiling cavity.

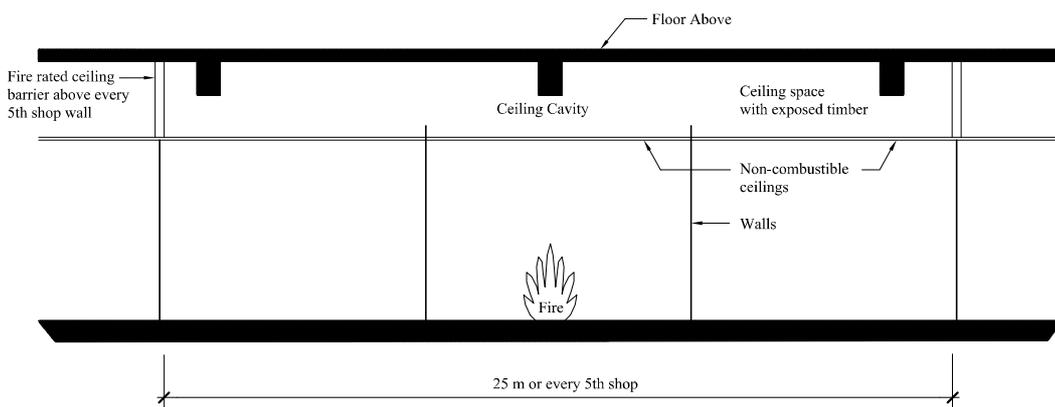
Where there is timber exposed in the ceiling cavity, fire rated ceiling barriers should be placed at closer spacings. Given the lack of a qualitative design method, it is recommended that they be placed at 25 m centres or at every 5th shop, whichever gives the closer spacing. This is to reduce the spread of the C3 fire and smoke. The fire rated ceiling barriers should be provided at the boundary between all shops (specialty shops and department stores) and the mall and between the specialty shops and the department stores. Figure 3 shows the fire rated ceiling barriers for this layout.

FIGURE 3: Fire rated ceiling barrier locations for timber exposed in the ceiling cavity.

Timber exposed in the ceiling cavity can include timber on the underside of the floor above. The non-combustible ceiling will delay the spread of fire into the ceiling space. Once the fire has broken through the ceiling, the timber exposed in the ceiling cavity will commence to burn. This will lead to accelerated spread of fire along the cavity, and the radiation from the combustion of the floor structure will contribute to, and speed up, the spread of the fire to the adjacent shops once the ceiling in the adjacent structure has collapsed.

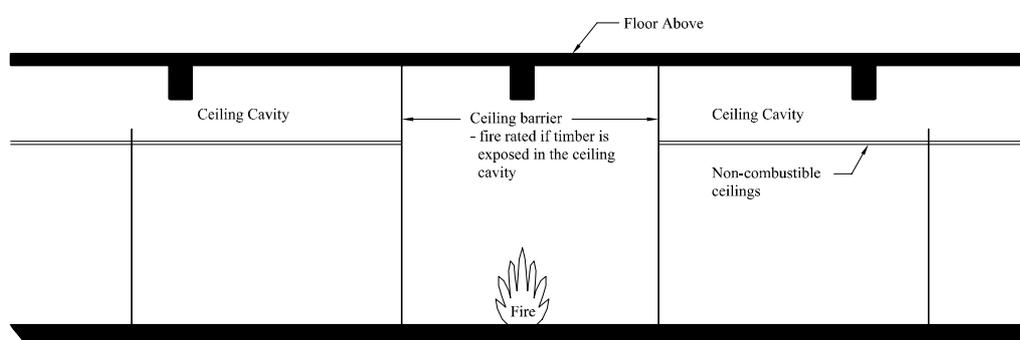
If no ceiling is present, there is no barrier to slow down the spread of fire to the ceiling space from the room of origin. The fire could spread rapidly into the ceiling space and into the adjacent shops once the ceiling in the adjacent structure has collapsed. Therefore, where there is no ceiling present, ceiling barriers should be provided to the periphery of the area. If there are no combustibles exposed in the ceiling cavity, the ceiling barriers should be of protected lightweight construction, eg. plasterboard linings on steel or timber studs. If there is timber exposed in the ceiling cavity, the ceiling barriers should be fire rated. Figure 4 shows the layout of the ceiling barriers for this configuration.

FIGURE 4: Ceiling barrier locations where no ceiling is present.

If there is no ceiling present, the underside of the floor above is exposed. Wood-based lining materials are not permitted on the ceiling, (Refer Section 3.5), therefore any timber exposed should be protected.
