**Project Report
FCRC PR 00-02**

Fire Safety in Shopping Centres

Effect of Combustible Construction on Fire Safety in Shopping Centres.

Fire Code Research Reform Program
February 2000

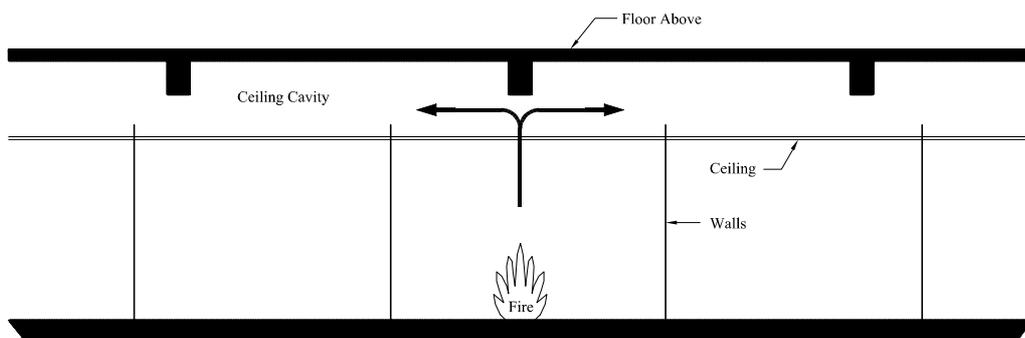
The review of the case studies indicated that non-compartmented ceiling spaces are a major cause of rapid smoke and fire spread. If the walls between the shops do not extend above the ceiling, providing a continuous ceiling cavity, then once the fire has broken through the ceiling, it can move horizontally within the ceiling space to adjacent stores. This method of fire spread is shown in Figure 1.

FIGURE 1: Fire spread through ceiling cavity

Fire spread to the adjacent stores, from the ceiling space, will occur by exposure of the combustibles to high levels of radiation when the ceiling has collapsed. If there is timber construction within the ceiling space, eg. the underside of the floor above is of timber, then the rate at which the fire will spread in this manner could increase. For fire spread through the ceiling space there are three combinations to be considered:

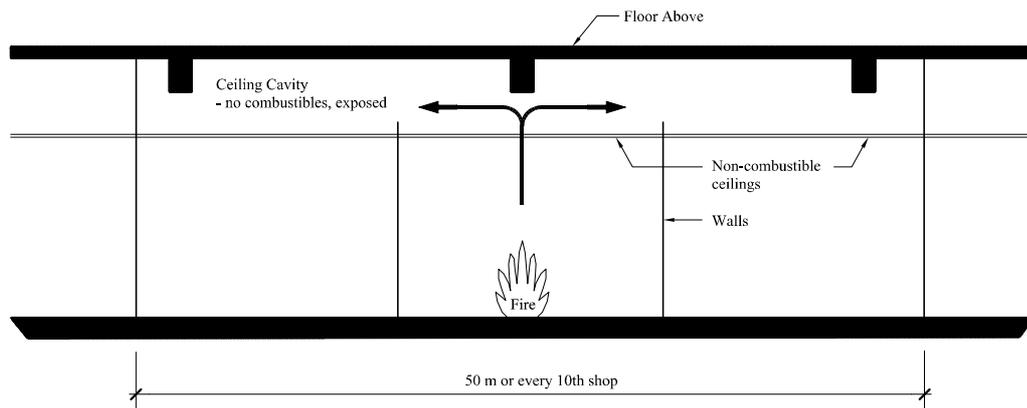
The presence of ceiling barriers at 50 m centres or every 10th specialty shop, whichever gives the closer spacing, as recommended by the Project 6 Report, would reduce the spread of the C3 fire and smoke. The ceiling barriers should be of protected lightweight construction, eg. plasterboard linings on steel or timber studs. There should be no gaps around the perimeter of non-combustible services penetrating the ceiling barriers. Any gaps around service penetrations through the ceiling barriers should be filled with a non-combustible material. This recommendation is more severe than the Project 6 Report which allowed a 50 mm gap around all penetrations. However, this recommendation is not requiring fire-rated construction, which would require additional expansive features such as fire dampers in ducts and intumescent collars around all plastic pipe penetrations. The ceiling barriers should be provided at the boundary between all shops (specialty shops and department stores) and the mall and between the specialty shops and the department stores. Figure 2 shows the ceiling barriers for this layout.

FIGURE 2: Ceiling barrier locations for no combustibles exposed in the ceiling cavity.

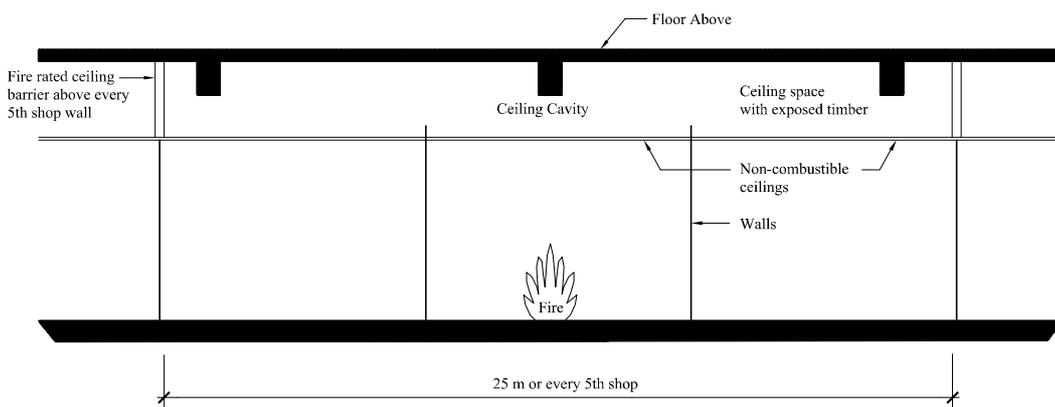
Where there is timber exposed in the ceiling cavity, fire rated ceiling barriers should be placed at closer spacings. Given the lack of a qualitative design method, it is recommended that they be placed at 25 m centres or at every 5th shop, whichever gives the closer spacing. This is to reduce the spread of the C3 fire and smoke. The fire rated ceiling barriers should be provided at the boundary between all shops (specialty shops and department stores) and the mall and between the specialty shops and the department stores. Figure 3 shows the fire rated ceiling barriers for this layout.

FIGURE 3: Fire rated ceiling barrier locations for timber exposed in the ceiling cavity.

Timber exposed in the ceiling cavity can include timber on the underside of the floor above. The non-combustible ceiling will delay the spread of fire into the ceiling space. Once the fire has broken through the ceiling, the timber exposed in the ceiling cavity will commence to burn. This will lead to accelerated spread of fire along the cavity, and the radiation from the combustion of the floor structure will contribute to, and speed up, the spread of the fire to the adjacent shops once the ceiling in the adjacent structure has collapsed.

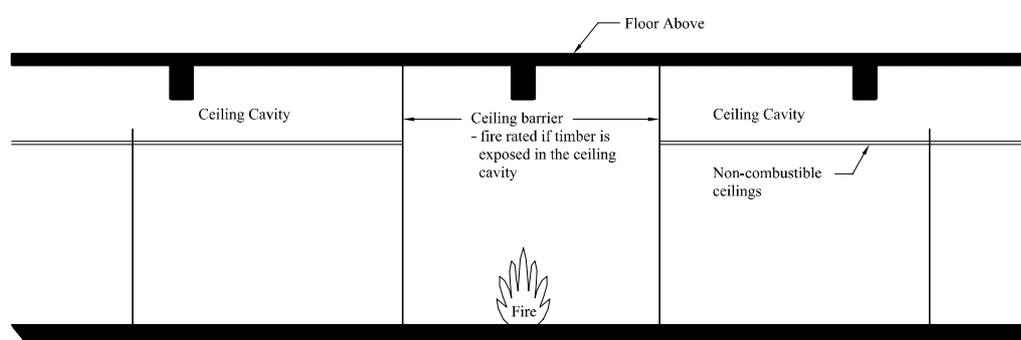
If no ceiling is present, there is no barrier to slow down the spread of fire to the ceiling space from the room of origin. The fire could spread rapidly into the ceiling space and into the adjacent shops once the ceiling in the adjacent structure has collapsed. Therefore, where there is no ceiling present, ceiling barriers should be provided to the periphery of the area. If there are no combustibles exposed in the ceiling cavity, the ceiling barriers should be of protected lightweight construction, eg. plasterboard linings on steel or timber studs. If there is timber exposed in the ceiling cavity, the ceiling barriers should be fire rated. Figure 4 shows the layout of the ceiling barriers for this configuration.

FIGURE 4: Ceiling barrier locations where no ceiling is present.
